# Manhole Inspection Summary

Manhole # S19AA\_003MH

Insp Date: **11/8/07 11:56 AM**

**Location** Address: **900 N PAYON ST** Cross Street: **W LAFAYETTE AVE**

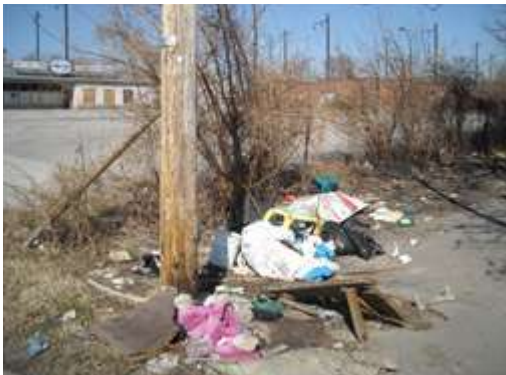
LOCATED VIEW

THIS IS WHAT THE SITE LOOKED LIKE  
WHEN WE ARRIVED

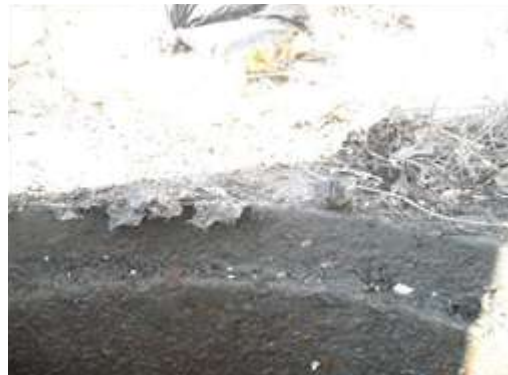
Defect 2

**Frame** Offset: **6** (in.) Condition: ☒ Sound ☐ Cracked ☐ Leaks

EVIDENCE OF INFLOW DUE TO  
PONDING AND FRAME OFFSET

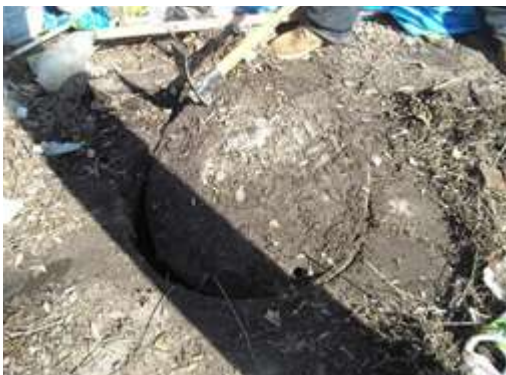
Defect 1

Comments **OBSERVED PILE OF DEBRIS WHERE MANHOLE WAS LOCATED - USING PICKAXE REMOVED DEBRIS AND SCRAPED ALLEY TO LOCATE MANHOLE LID. OPENED USING 16LB SLEDGE AND PRYBAR TO BREAK SEAL. INSEPECTION COMPLETE.**

MANHOLE WAS PREVIOUSLY  
BURIED BY DEBRIS

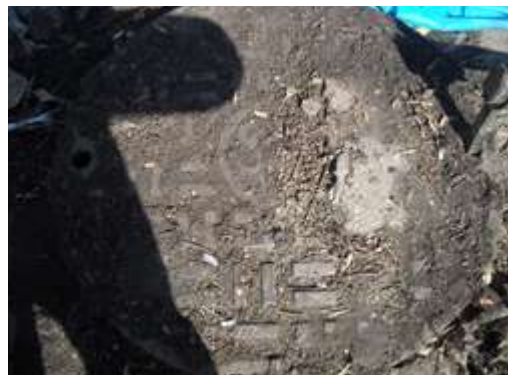
Defect 5

**Cover** Shape: **Circular** Diameter: **24** (in.) Length: (in.) Dist A/B Grade: **0** (in.)  
Type: **Sanitary** Condition: **Worn** Cover Material: **Cast Iron**  
Properties: ☐ Bolted ☐ Vented ☐ Water Tight ☐ Water Tight Insert

LID IS WORN

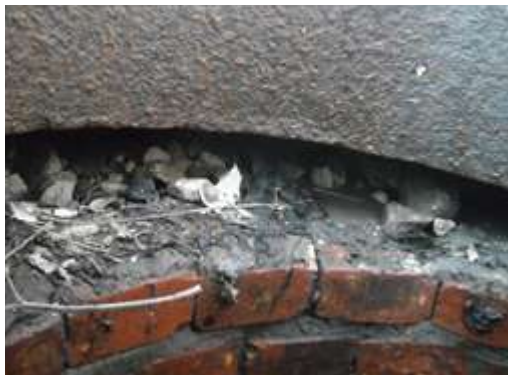
Defect 4

**Chimney / Frame Adjustment** ☒ Exists Material: **Brick** ☐ Parged Height: **3** (in.)  
Condition: ☐ Sound ☐ Cracked ☐ Root Intrusion ☒ Loose Brick ☒ Deteriorated  
Infiltration: ☒ None ☐ Joint ☐ Cracks ☐ Mortar ☐ Roots ☐ Wall

GAP BELOW FRAME OF 3"

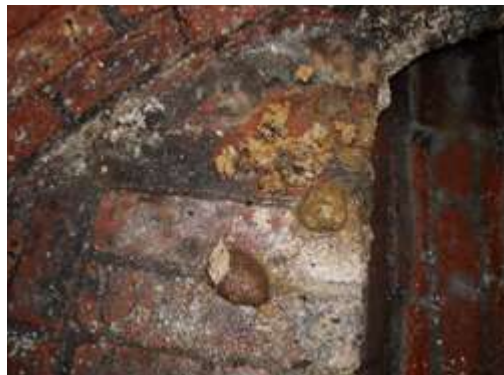
Defect 3

**Surcharge** ☒ Evidence Of Surcharge Depth: **1** (ft.) ☐ Active Surcharge Present

EVIDENCE OF PRIOR SURCHARGE AT  
1'

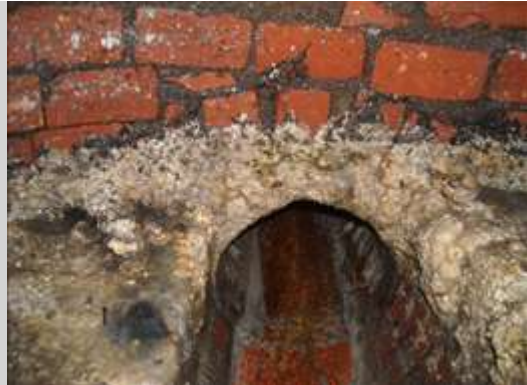
12 O'Clock Outflow

EVIDENCE OF PRIOR GREASE  
SURCHARGE AT THIS

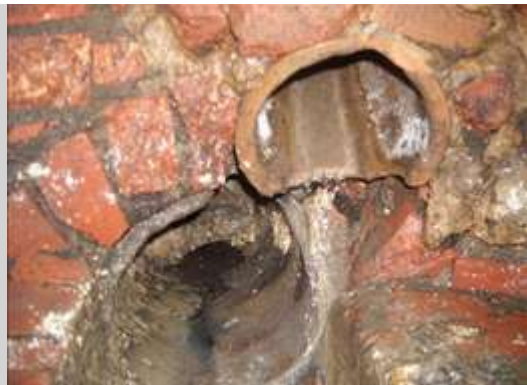
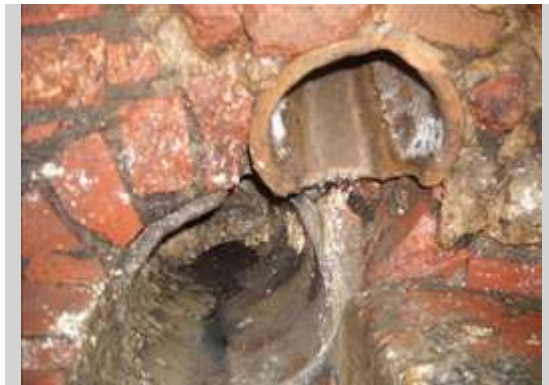
3 O'Clock Inflow

Drop: **Inside** Rod and Bar  
Angled: **Yes** Reading: **6.28** (ft.)  
Inv Depth: **7.28** (ft.)

Drop Condition: **Open**
